# Initial House Assessments & Sealing Options:

July 2017

Dave Bohac, PE  
Center for Energy and Environment

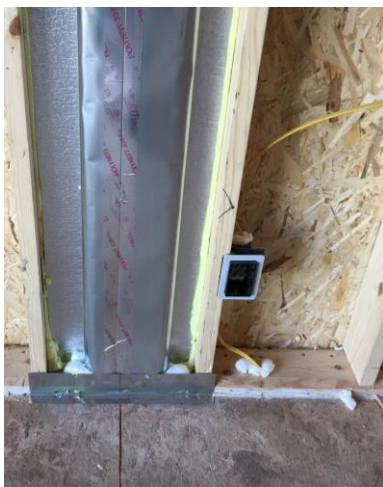
Duct and electric penetration thru exterior wall base plate

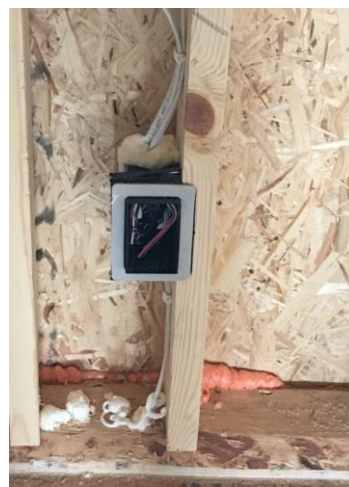
Air-tight electric box at exterior wall; caulk base plate/floor joint

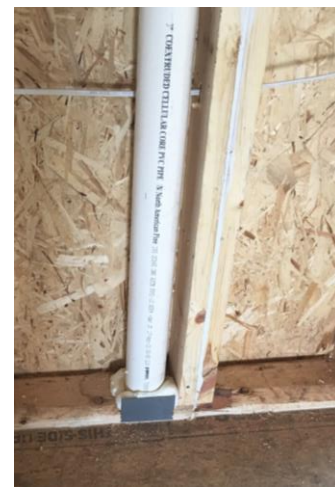
Plumbing penetration and caulk gap between studs

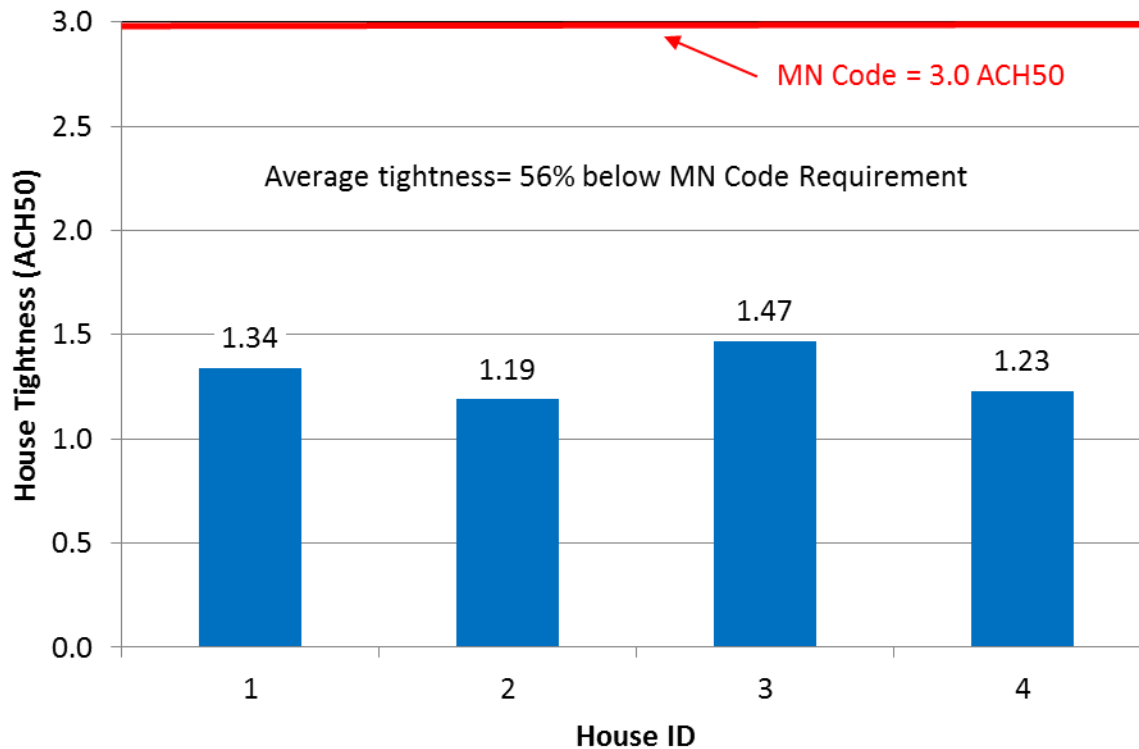
Figure 2. House tightness test results from four HERS rater reports

The HERS rater reports indicated consistently tight houses with quality air sealing practices. We reviewed HERS rater reports on four houses to evaluate the typical air leakage achieved and any common air leakage issues for recently completed houses. The HERS rater reports indicated consistently tight houses with quality air sealing practices. The reports were conducted for houses with a floor area of 3,647 square feet located in Cottage Grove, Minnesota (3 houses) and Lakeville, Minnesota (1 house). The inspections were conducted from August 17, 2016, to March 7, 2017. As shown in Figure 2 below, the air leakage test results ranged from 1.19 to 1.47 ACH50, which is 51% to 60% below the State of Minnesota code requirement of 3.0 ACH50.

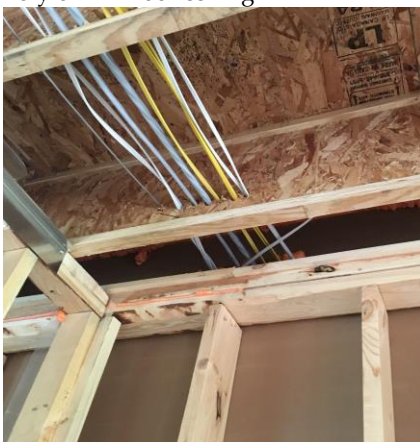
Foam seal electrical penetrations to garage

Spray foam was used to seal multiple gaps between the first floor living space and garage prior to the AeroBarrier sealing. These included large ( $> 3/8"$ ) gaps around electrical penetrations, duct penetrations, and near ceiling joists.

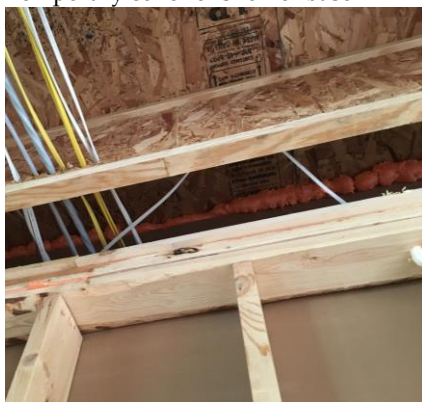
Foam seal gap at top of garage drywall

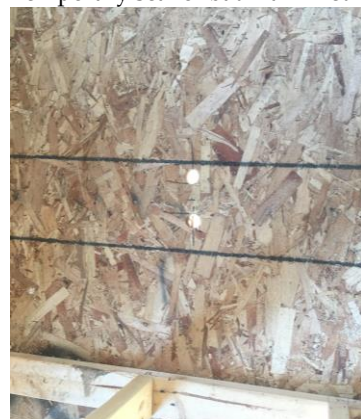
Tape used to temporarily seal 1" holes in flooring

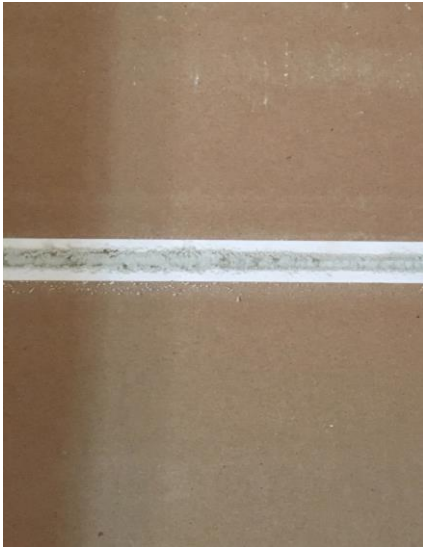
Gap between drywall sheets

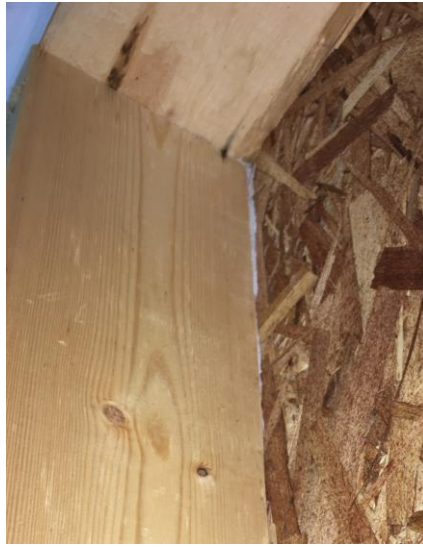
Gap between framing and sheathing

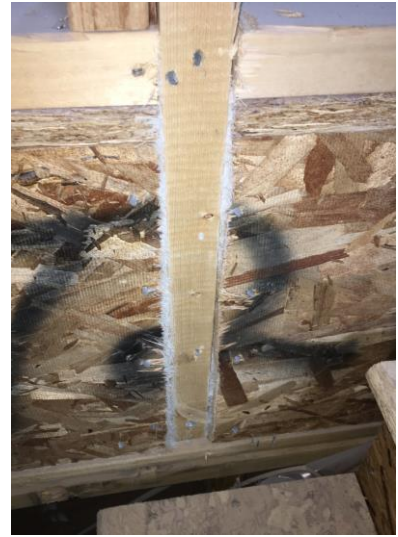
Rim joist gaps

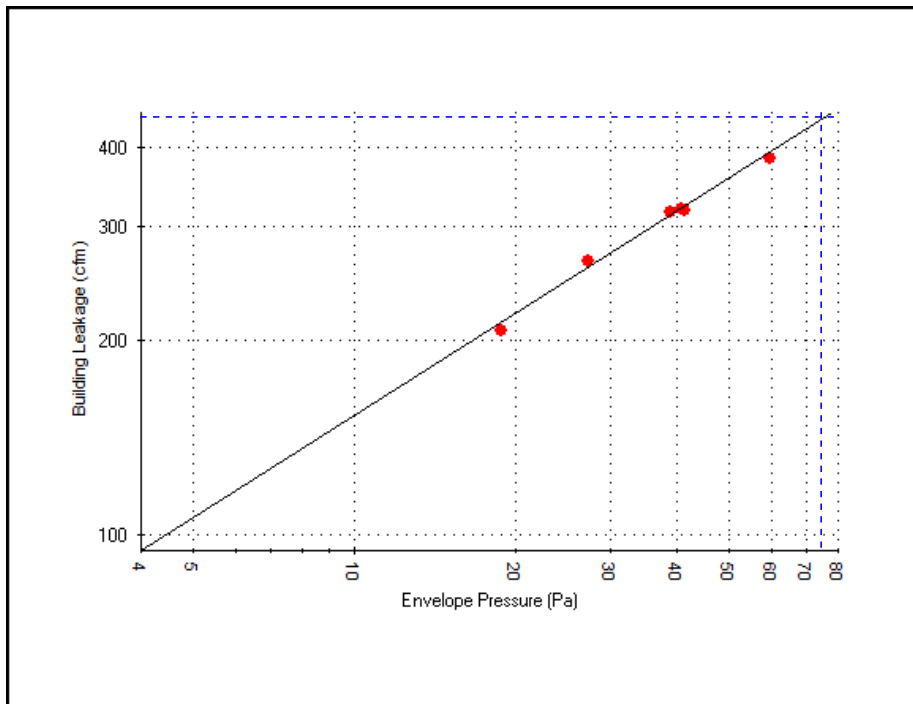
Figure 7. Post-sealing house leakage measurements

A multi-point house leakage measurement at the end of the AeroBarrier sealing resulted in a tightness of 358 cfm<sub>50</sub> or 0.64 ACH<sub>50</sub> (see Figure 7). The reduction of 84% is consistent with the reductions obtained for previous projects. This is 79% below the State of Minnesota code requirement of 3.0 ACH<sub>50</sub>. It is also 51% less than the average house tightness of 1.31 ACH<sub>50</sub> for the four completed HERS rated houses and only 7% higher than the Passivhaus standard of 0.6 ACH<sub>50</sub>. This very tight construction was achieved without the poly vapor/air barrier in place on the walls and without the spray foam insulation/air sealing of the rim joists. This suggests that the current level of house tightness of 1.3 ACH<sub>50</sub> could be produced without much of the current air sealing when AeroBarrier sealing is applied.
