Initial House Assessments & Sealing Efforts:

California Builder #1

Aerosol Sealing Installation Phase I: California Builder #1

November 2017

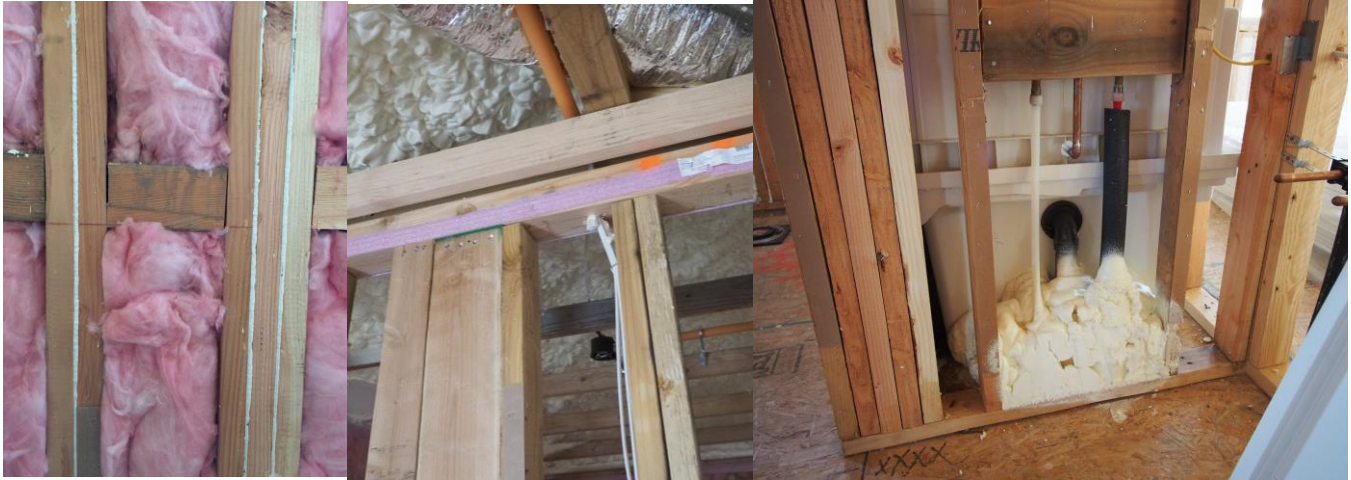
Figure 1. Air sealing details

Can foam used between double studs Foam gasket to seal drywall between house and attic Spray foam used at plumbing penetrations

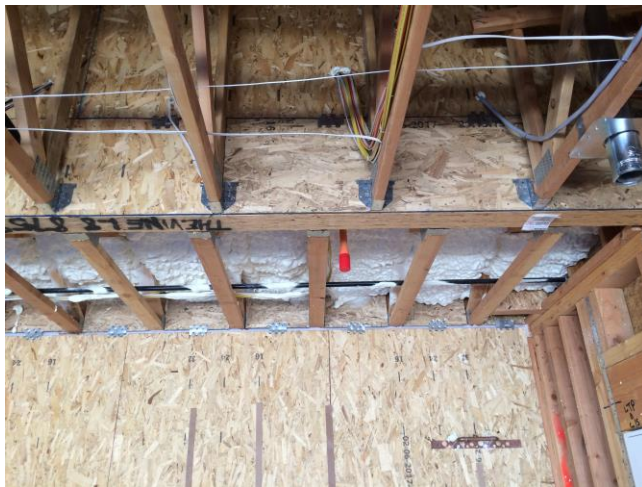
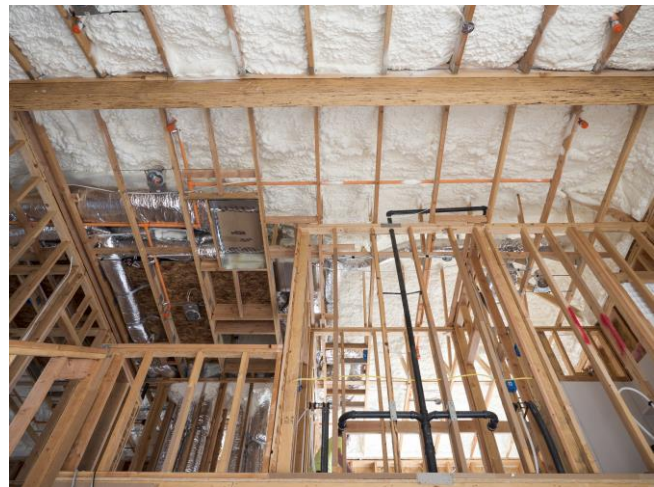
Open-cell spray foam installed at rim joist
Figure 3. Photos of homes sealed under Option 1

Open-cell spray foam installed below roof deck

AeroBarrier sealing for Option 1 occurred after open-cell spray foam was installed at the rim joist and below the roof deck (Figure 3). No additional sealing was performed prior to the AeroBarrier installation. The pre-sealing results showed air leakage of 4.39 and 3.47 ACH₅₀ for the two homes during this stage of construction.

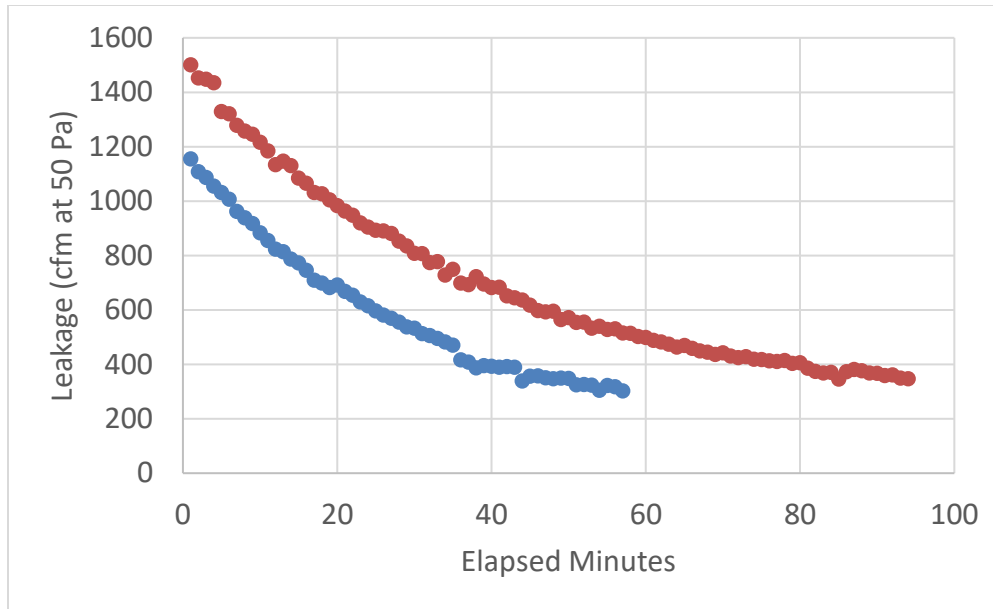
Figure 4. Sealing profile for both houses sealed under Option 1

The AeroBarrier sealing was very successful. The sealing was conducted for 1-1.5 hours (see AeroBarrier sealing reports in the Appendix). The overall time to seal each home including prep and cleanup was about 3 hours. The leakage at the start of the sealing was between 1,200-1,500 cfm50. Figure 4 shows the sealing profile for both sealing demonstrations under Option 1. There were slight differences in the time required for sealing and the starting leakage rate which is likely due to differences in the floorplan for the homes. The AeroBarrier reduced the leakage in both cases by about 75% bringing them down to 1.11 and 0.95 ACH50 which is roughly 80% below the California requirement of 5 ACH50.

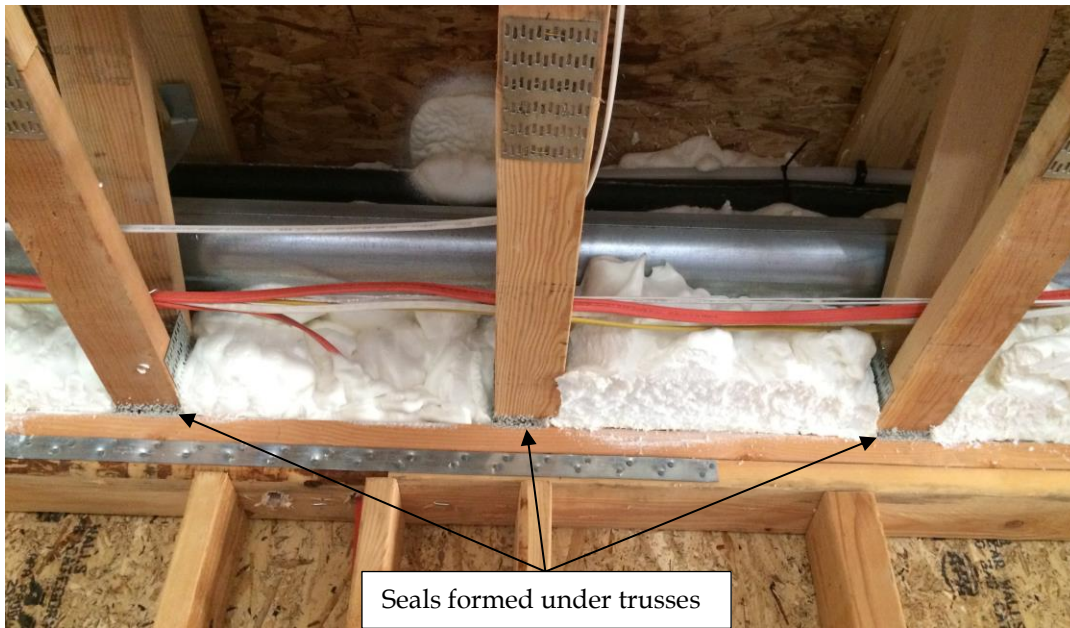
Figure 5. Photo of seals formed below each truss on first floor

While the open-cell spray foam sealed a significant amount of air leakage, the AeroBarrier still found locations that the foam did not seal. Figure 5 and 6 show photos of some of the locations that AeroBarrier seals were found. Many of these locations were between wood studs that were too small for the spray foam insulation. These were also not standard locations for installing can foam.

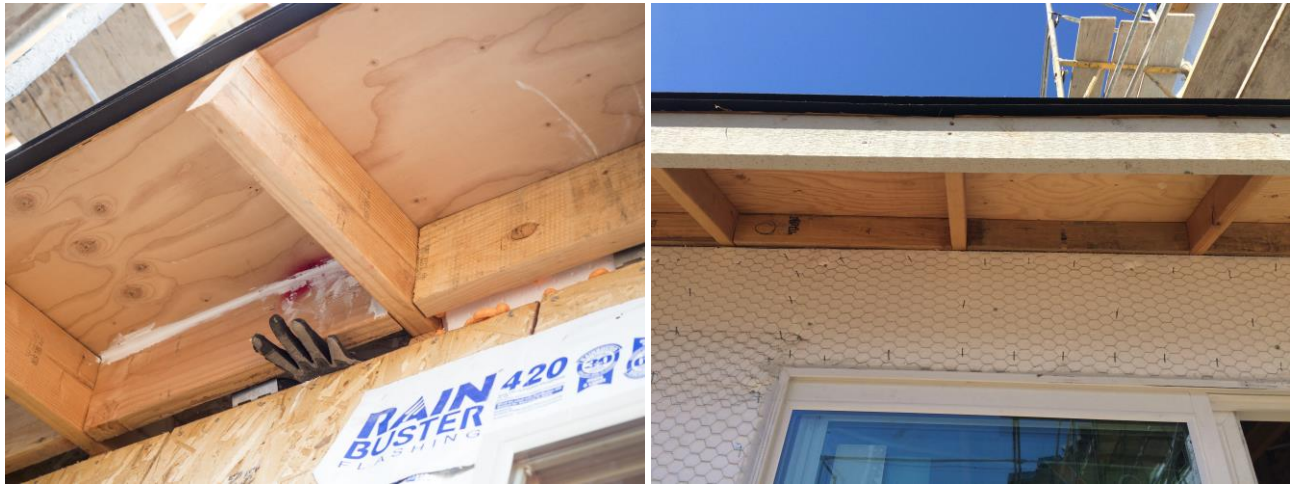
Figure 7. Gap at eaves requiring manual blocking prior to AeroBarrier (left), example of exterior ridged foam used to close the gap prior to open-cell spray foam installation (right)

AeroBarrier sealing for Option 2 occurred before open-cell spray foam was installed and represents the first opportunity to seal the homes since the building shell is largely complete. Some manual sealing prior to installing AeroBarrier was required to block larger penetrations that would not be sealed efficiently with the aerosol. The time and materials required to perform that sealing were documented. There were also some issues coordinating the sealing demonstrations with the home builder which led to some additional gaps at the eaves of the home that would normally have been blocked prior to the AeroBarrier installation (Figure 7 and 8).

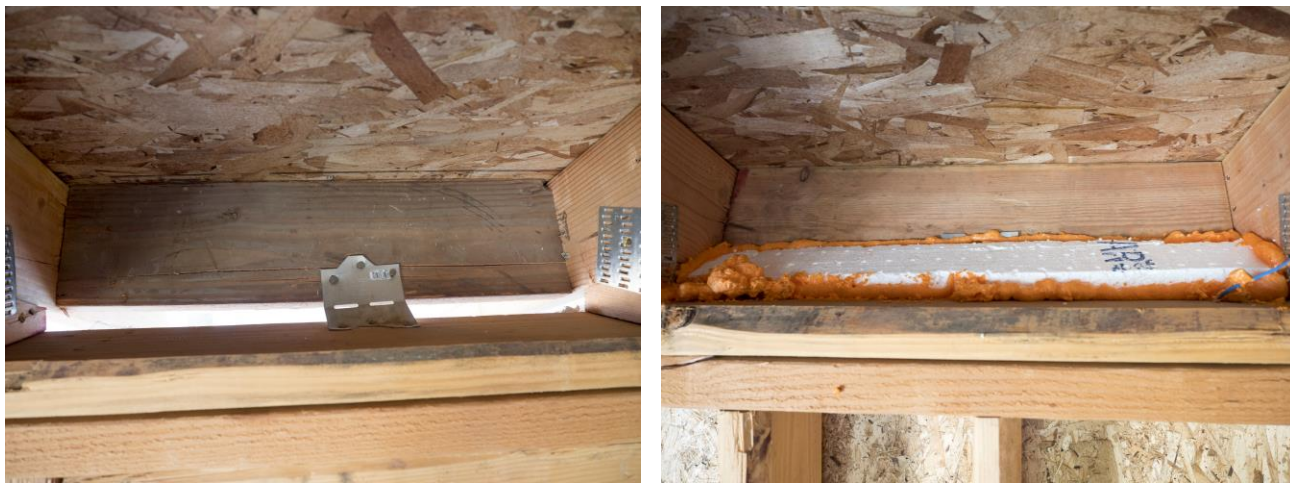
Figure 8. Gap at eave prior to sealing (left) and after sealing with ridged foam and can foam (right)

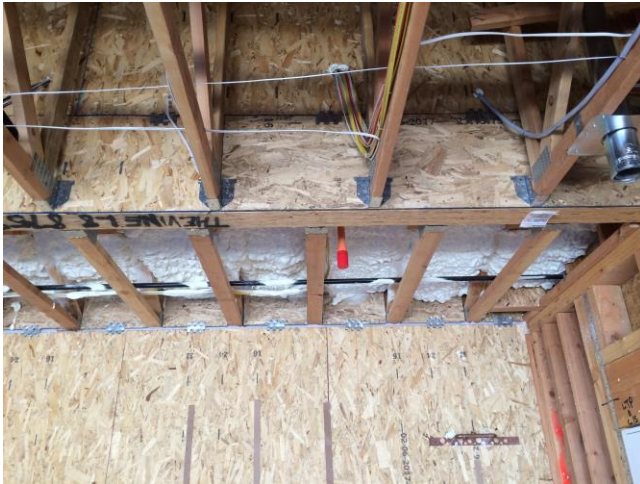
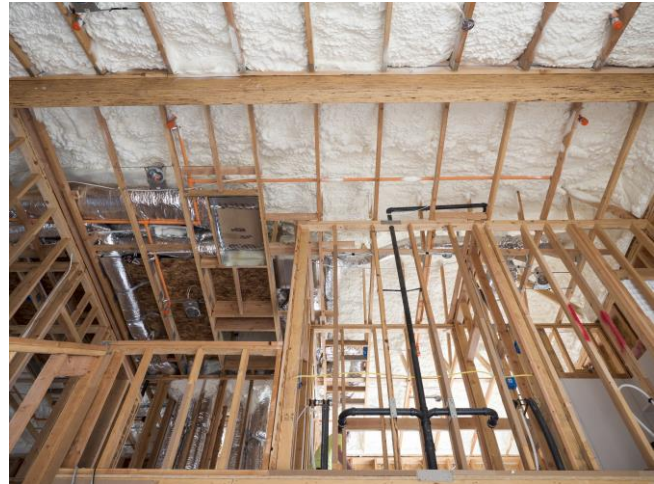
Open-cell spray foam installed at rim joist
Figure 9. Photos of homes sealed under Option 1

Open-cell spray foam installed below roof deck

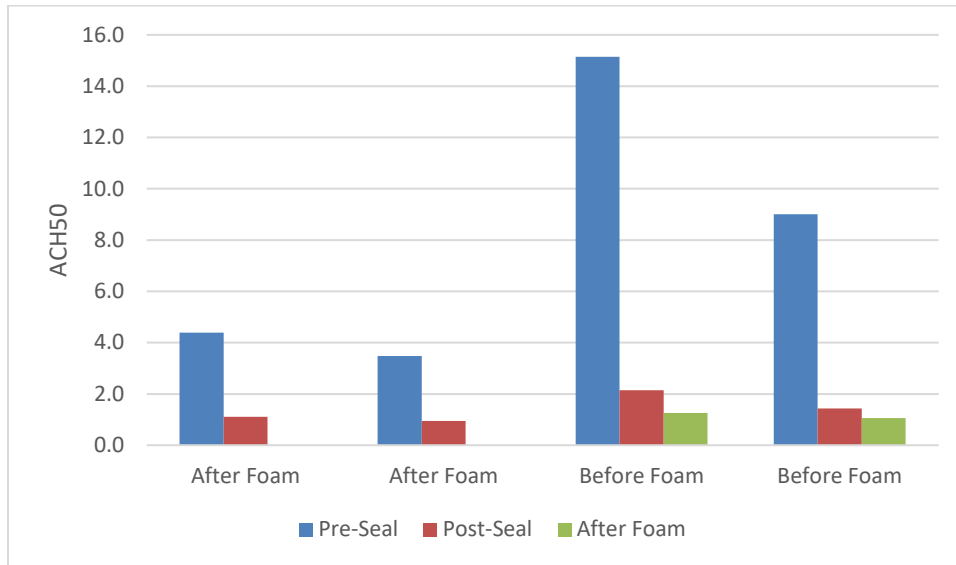
Figure 11. Air leakage results summary for all homes at each stage of process

Table 4 and Figure 11 provide a summary of all of the AeroBarrier sealing results for the first round of tests for the homes in Lodi, CA. Overall, nearly 10,000 CFM50 of air leakage was sealed in 8 hours of total injection time over two days. The average air tightness achieved was 1.09 ACH50 before drywall was installed in the homes. A final air leakage test will be performed once the houses are complete and compared to other homes that did not receive the AirBarrier treatment.

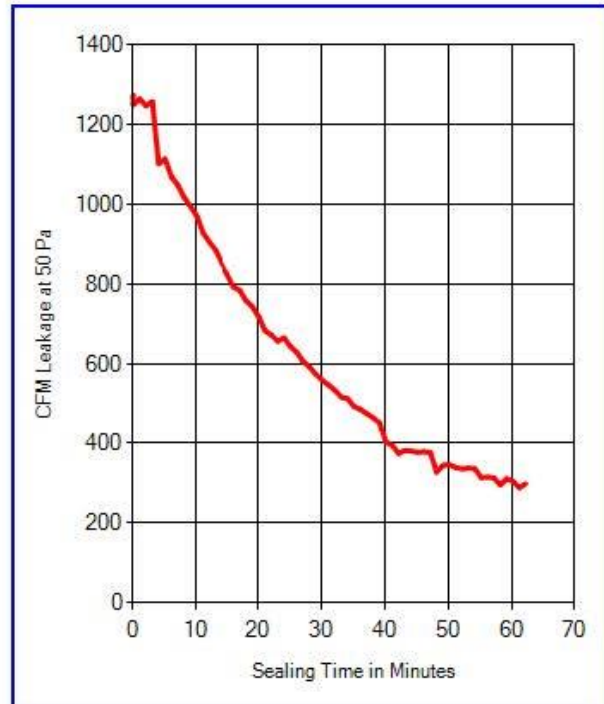
1275.8 CFM of Leakage, equivalent to a
159.0 Square Inch Hole or **4.7 Air Changes per Hour**

298 CFM of Leakage, equivalent to a
37.1 Square Inch Hole or **1.1 Air Changes per Hour**

This corresponds to a **76.6% Reduction in Envelope Leakage**.
